IMPROVEMENT LOCATION REPORT

that on \_\_\_\_\_, 20\_\_\_\_, I made an accurate inspection of the premises situated at PLACITAS SANDOVAL County, N.M., briefly described as : 72 ANASAZI TRAILS ROAD  
 (Address, if applicable)

LOT 51, ANASAZI TRAILS SUBDIVISION, AS SHOWN AND DELINEATED ON THE PLAT THEREOF FILED ON MARCH 3, 2003 IN VOLUME 3, PAGE 2264-B IN THE RECORDS OF THE SANDOVAL COUNTY, NEW MEXICO.

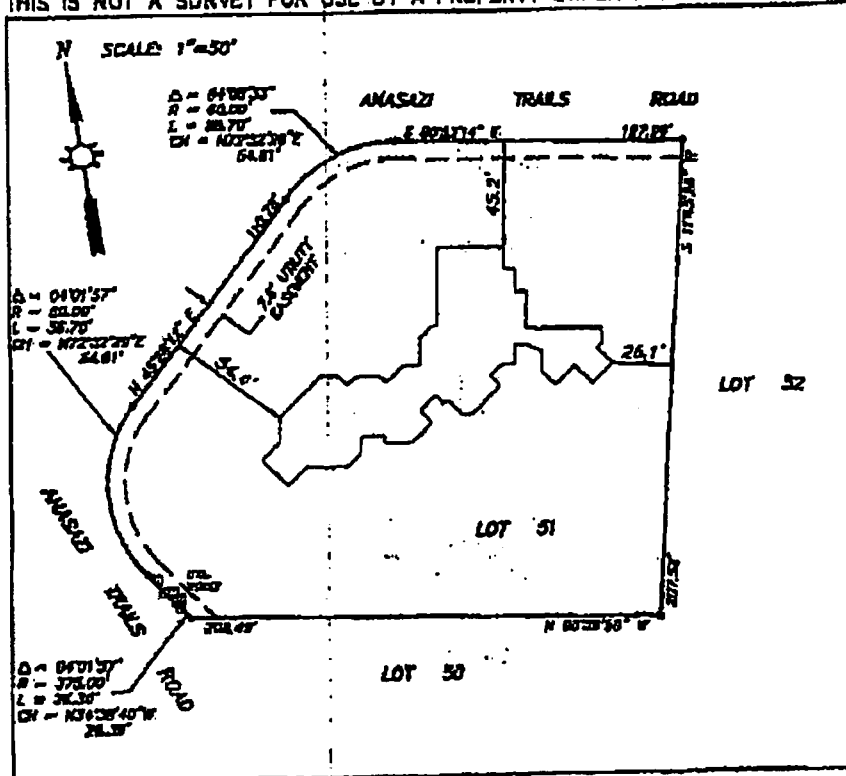
SEE SKETCH FOR LOCATION OF UTILITY BOXES

FOUND CAPPED REBARS AT PROPERTY CORNERS

SETBACKS COMPLY
