# **VIDEO CAMERA INSPECTION REPORT**

**INSPECTED FOR**  
Cynthia Sands  
22137 Teri Court, West Hills  
February 1, 2012

**SUBJECT:** Waste and Sewer Pipeline Video Inspection at 22137 Teri Court, West Hills

# WASTE AND SEWER PIPELINES VIDEO INSPECTION REPORT

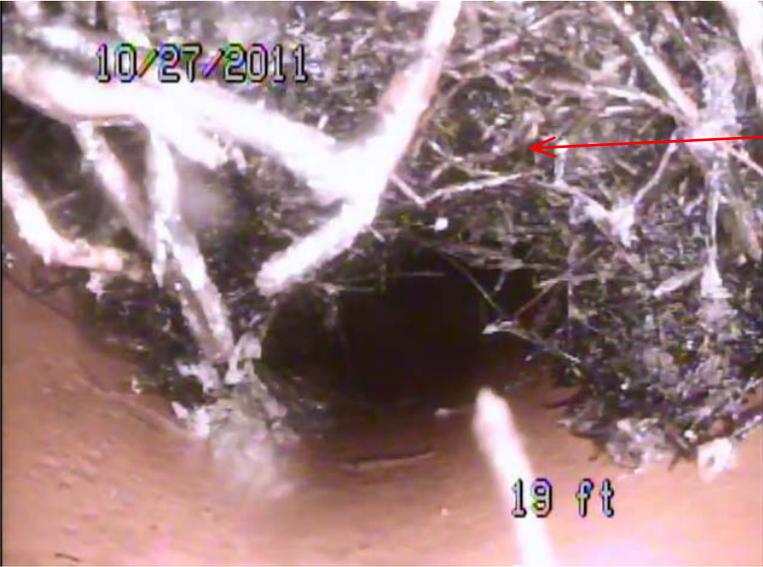
Root infiltrated pipes: About 22 feet long of pipe from public sewer inlet onward is heavily infiltrated with tree roots. Large tree and several shrubs were planted nearby.

**Photo #1**  
Tree roots infiltration in sewer pipe, 22 feet long

Root infiltrated pipes: Remove tree roots from sewer drain pipes by using a drain auger or high pressure hydro water drain jetting system. Remove the tree and shrubs if possible.

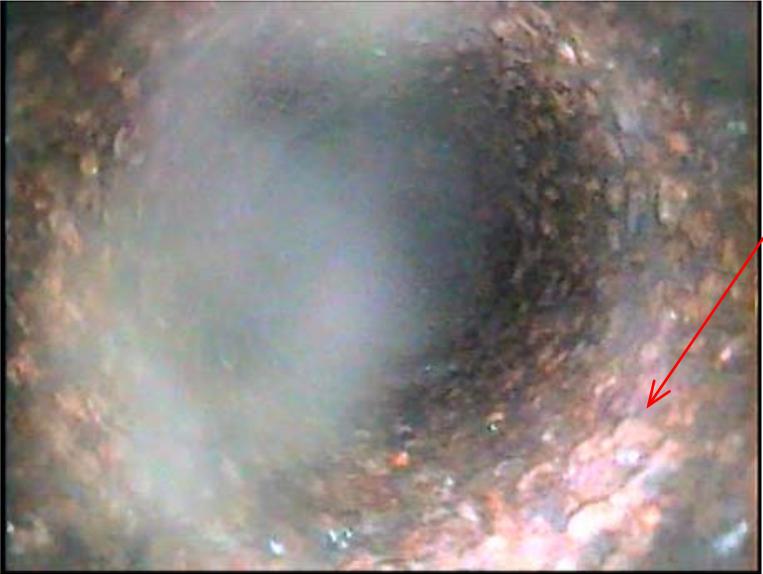
Corroded pipe: About 95 feet long cast-iron pipe from the connection with vitrified pipe is moderately corroded.

**Photo #2**  
Moderately corroded cast-iron pipe, 95 feet long from the connection with vitrified clay pipe

Corroded pipe: It is not necessary to replace the pipe at this time.

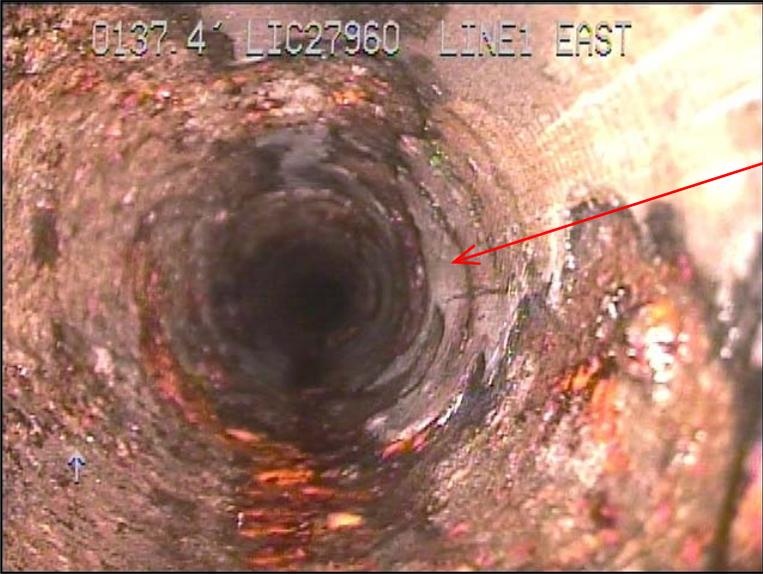
**Photo #3**  
Heavily corroded cast-iron pipe
