### SELLER'S DISCLOSURE STATEMENT

1 To be completed by **SELLER** concerning 7035 Forsyth Blvd, University City, MO, 63105 (Property Address) located  
2 in the municipality of University City (if incorporated), County of St. Louis, Missouri.  
3 **Note: If Seller knows or suspects some condition which might lower the value of the property being sold or adversely affect**  
4 **Buyer's decision to buy the property, then Seller needs to disclose it. This statement will assist Buyer in evaluating the property**  
5 **being considered. Real estate brokers and agents involved in the sale do not inspect the property for defects, and they cannot**  
6 **guarantee the accuracy of the information in this form.**

The tile roof on the house consists of a Green Glaze Spanish Tile. This type of tile is an alternative version of a similar Red Spanish Tile. The glaze is an upgrade to an already good product, which is an unglazed tile. The glaze cost more and can work to protect the ceramic/clay material that make up a tile roof. We inspected the felt underlayment at 5 random areas and found it to be in good condition. [ Sample pictures included below] This is good indicator of the overall qual

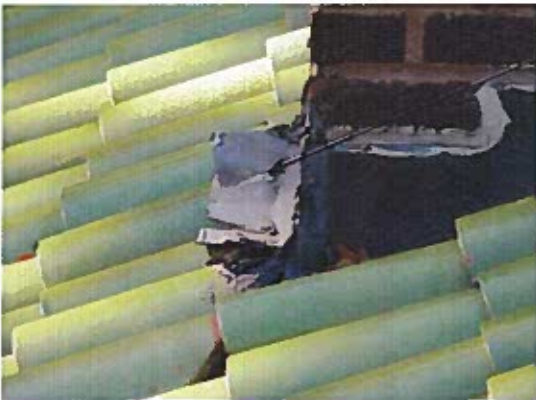
The rear chimney has the original copper flashings, while the front chimney has been replaced with new copper. There were a few minor flaws at the front copper flashing located on the front Southeast chimney. This can be corrected with a reasonable effort, [see B below].

- Seal open vent pipes and chimney flashings.
- Inspect metal valleys and chimneys backs for any worn holes, repairing as needed to prolong life of metal.
- *Close attention will be paid to the western slope.*

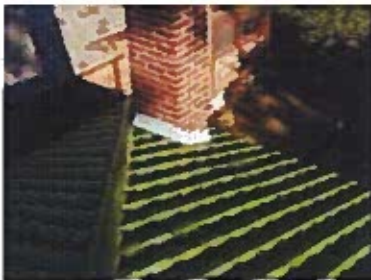
Rear Chimney

I also noticed a few minor defects at the rear/west side section of the Southeast front chimney. The defects are called *pop outs*, which means some of the brick joints have fallen out. Minor touchups can be performed while we're on the roof. [See C below]

Overall, the chimneys in the flashings were in good condition

While we are on the roof, we will repair the existing pop outs located on the Southeast chimney, on the rear facing. These areas will be pointed with mortar matching as close as possible.
