Wood Destroying Insect Inspection Report

69 Calle del Norte.
Placitas, New Mexico 87043.

Attachment- Photos for Wood Destroying Insect Inspection Report

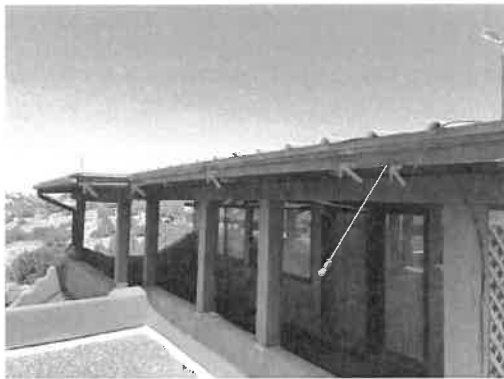
DryRot.

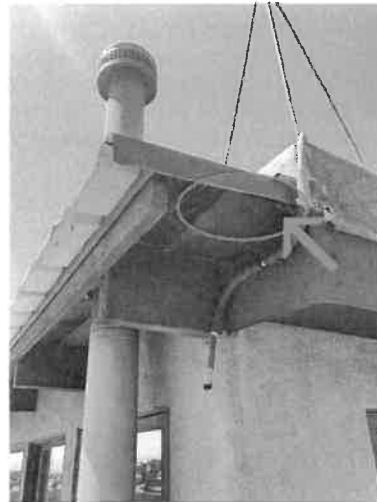
DryRot.

- A. NO VISIBLE EVIDENCE OF WOOD DESTROYING FUNGI WAS OBSERVED
- B. VISIBLE EVIDENCE OF WOOD DESTROYING FUNGI WAS OBSERVED AS FOLLOWS:
- Fungi observed (description and location): _____
-
- Any fungi observed appears:
- Active Inactive
- Treatment Recommended
- Damage from wood destroying fungi was noted in the following area(s): DryRot balcony fascia & SE soffit.

Repair in process
